SUMMARY TECHNICAL INSPECTION
WTG 20675 VESTAS V80-2000KW-690V-
50HZ-R.7035

25/11/2021

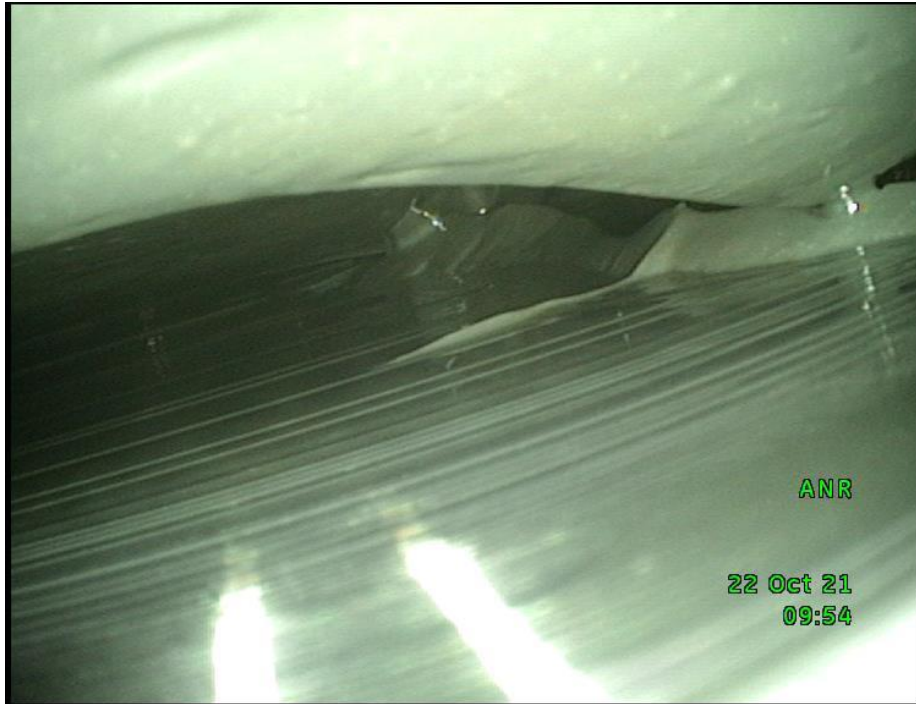
FRONT MAIN BEARING: The visual part of the main bearing shows no irregularities. The colour of the grease is correct and the grease is not magnetic.

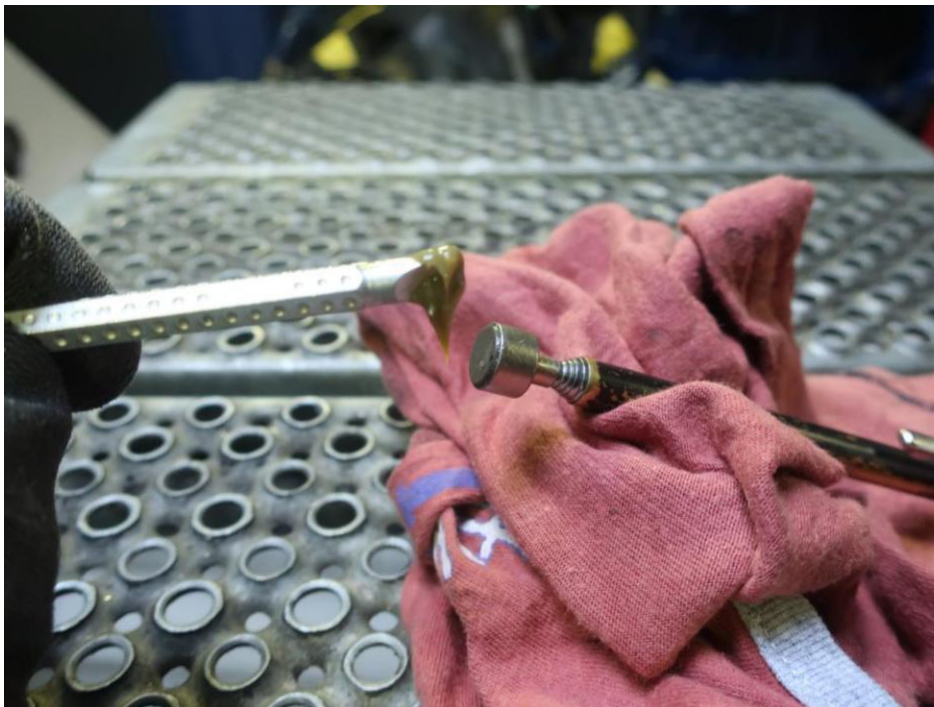
REAR MAIN BEARING: The bearing is filled with grease and not accessible with scope. The colour of the grease is correct and the grease is not magnetic.

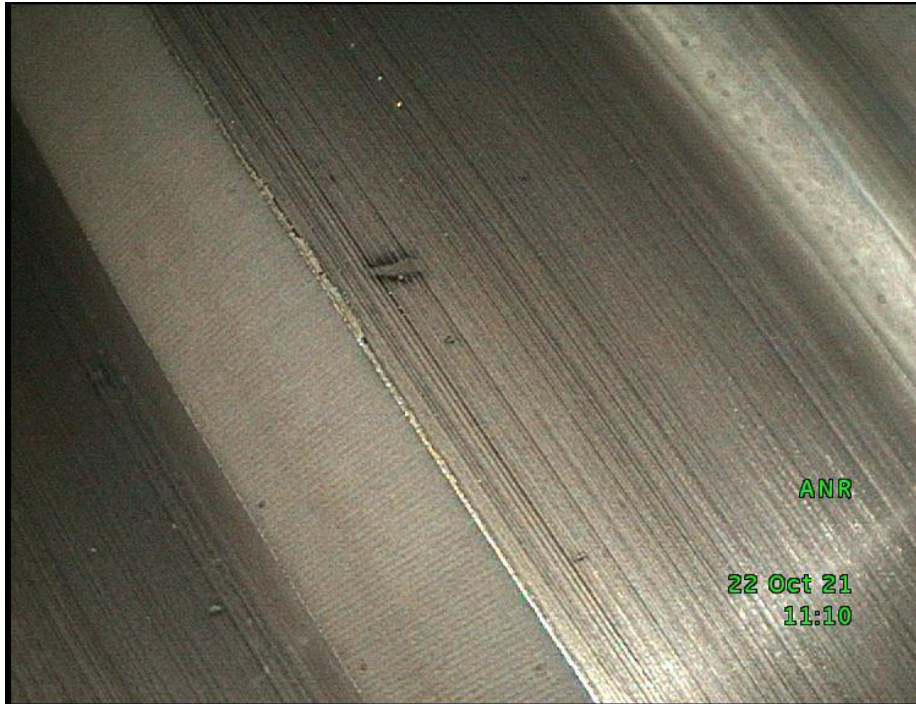
The active flank of the ring gear shows a lot of indentations.

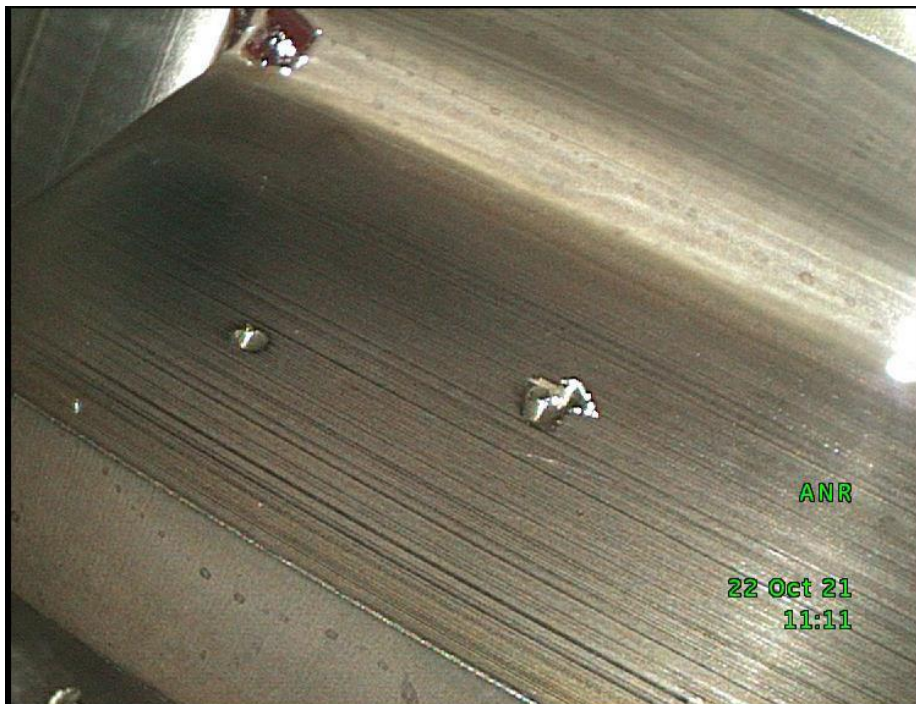
The active flank of the ring gear shows a lot of indentations.

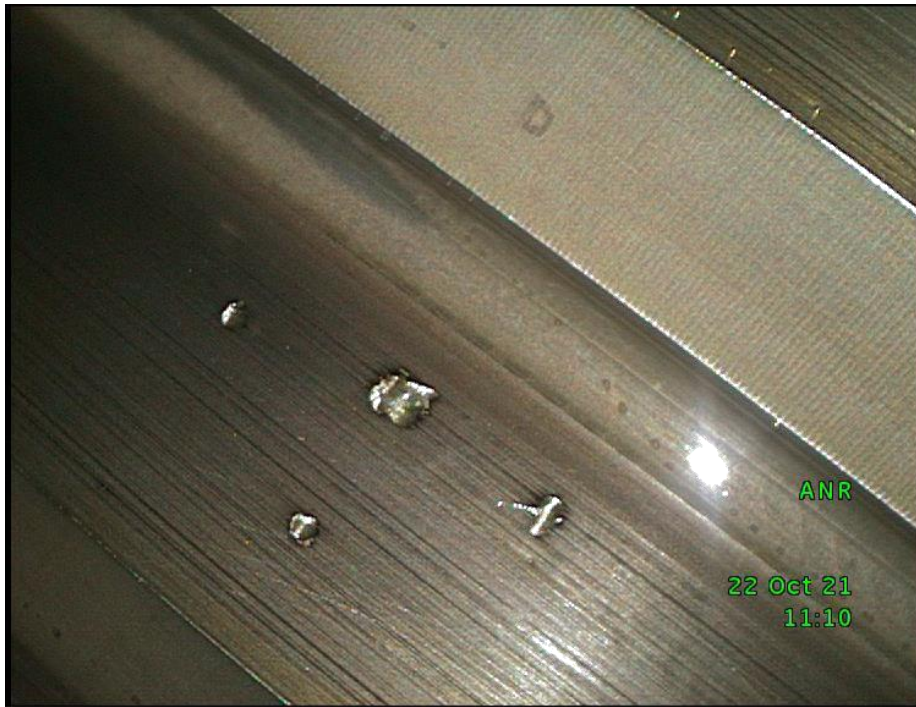
The active flank of the ring gear shows a lot of indentations.

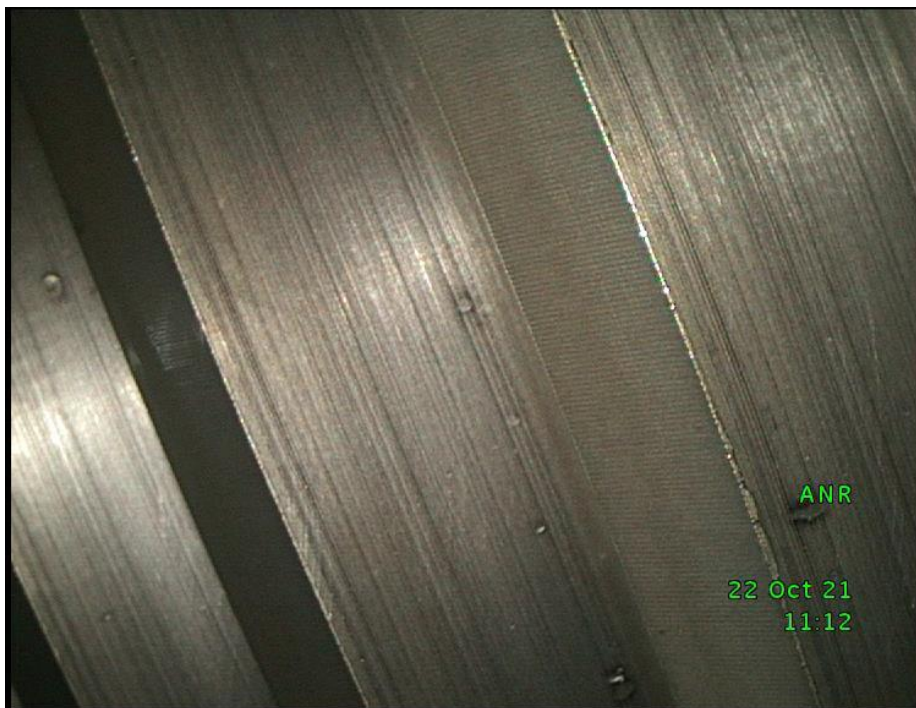
The active flank of the ring gear shows a lot of indentations.

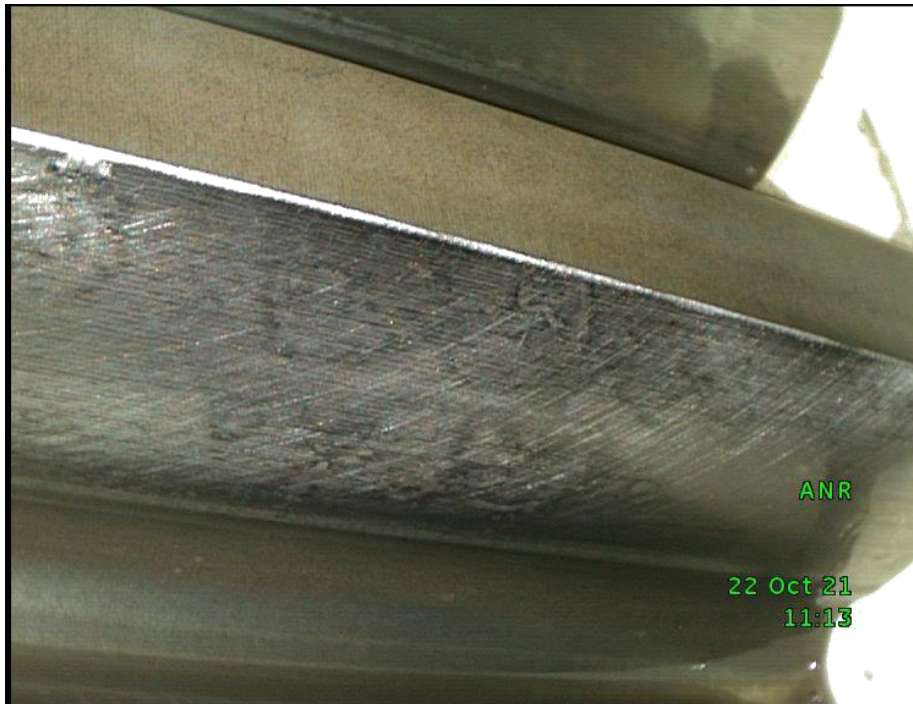
The planet wheels show a lot of irregularities on the surface.

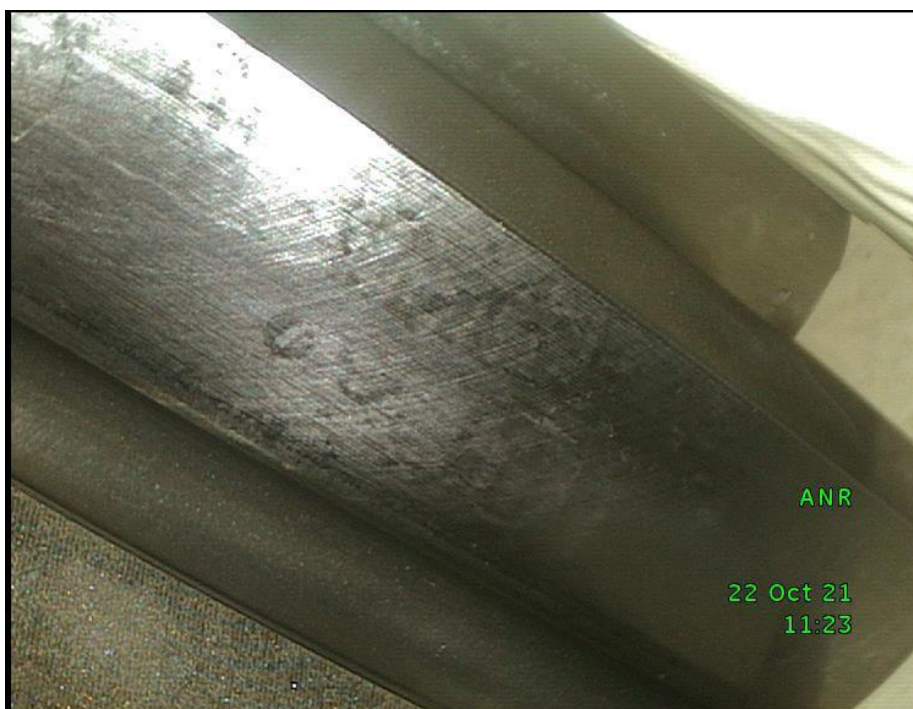
The planet wheels show a lot of irregularities on the surface.

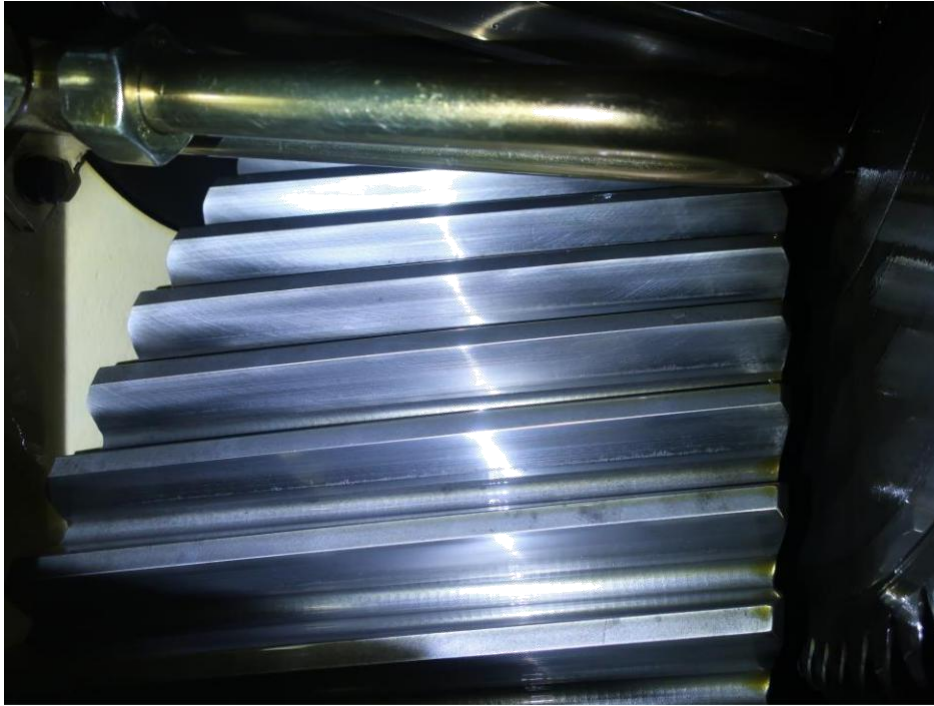
Linear gears show no irregularities

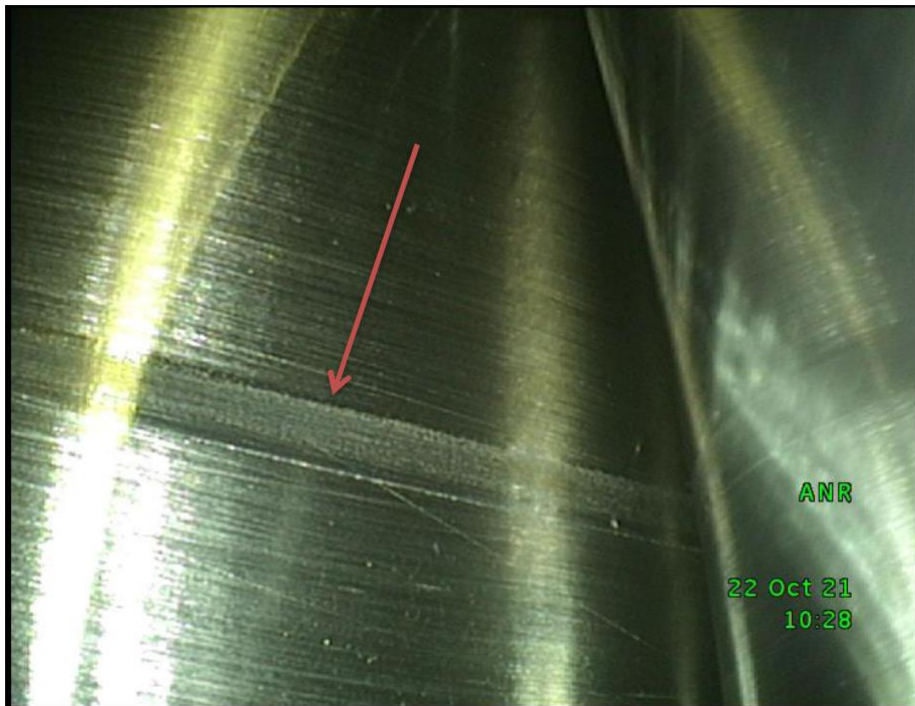
The planet wheel bearings show small irregularities. This planet bearing has a grey radial line.

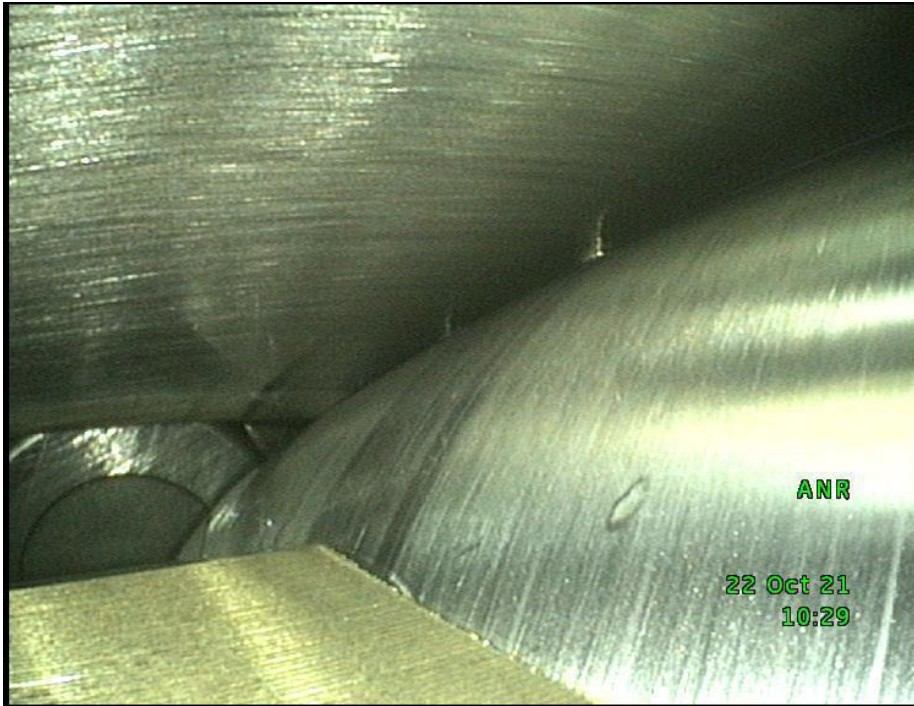
The planet wheel bearings show small irregularities. This planet bearing shows a small indentation.

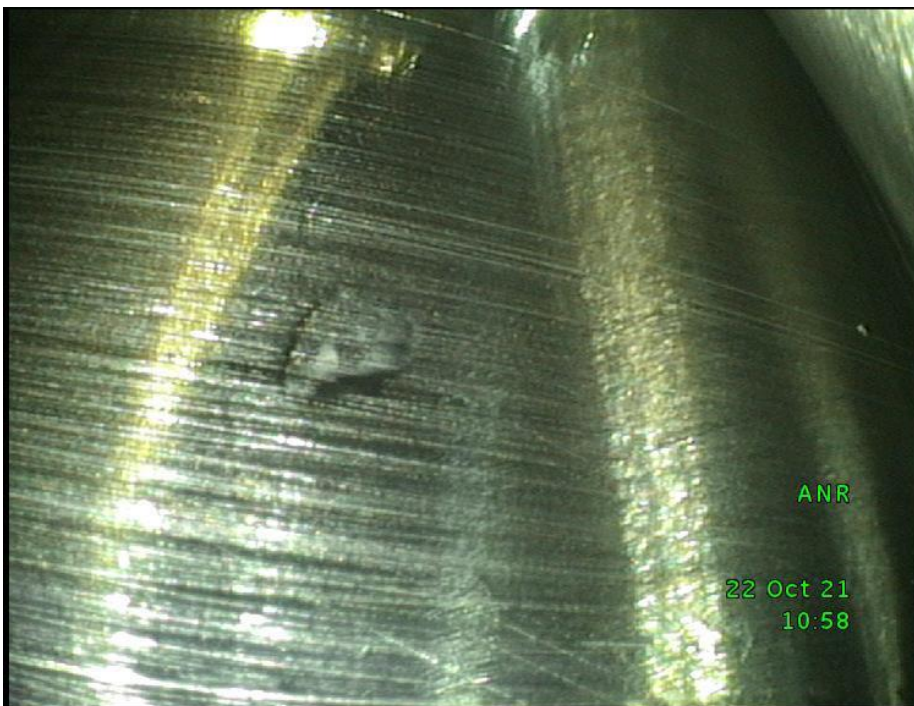
The planet wheel bearings show small irregularities. This planet bearing shows a small indentation.

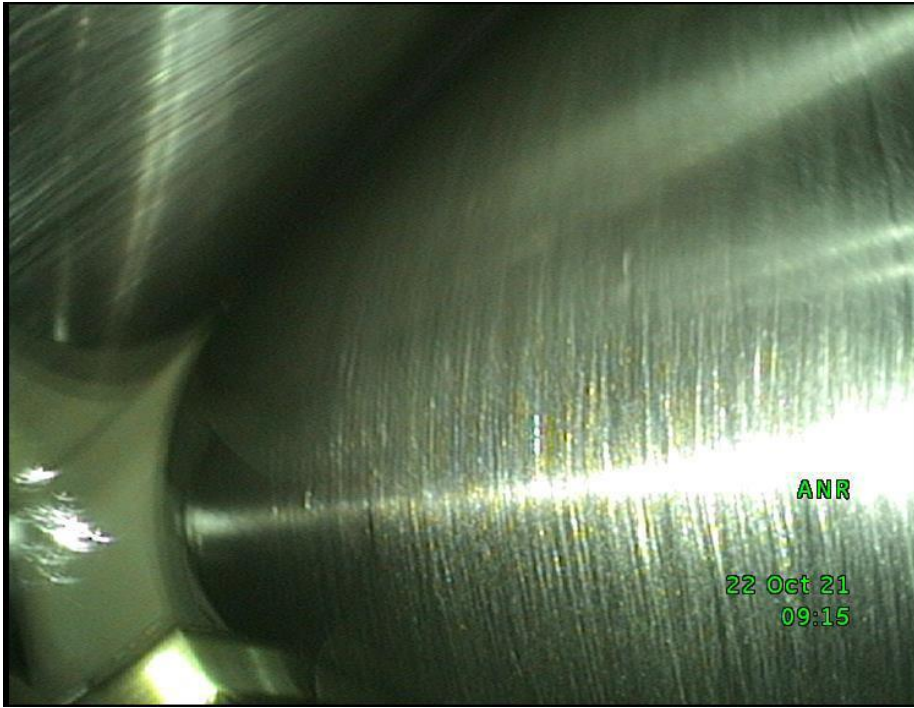
Linear bearings show no irregularities.

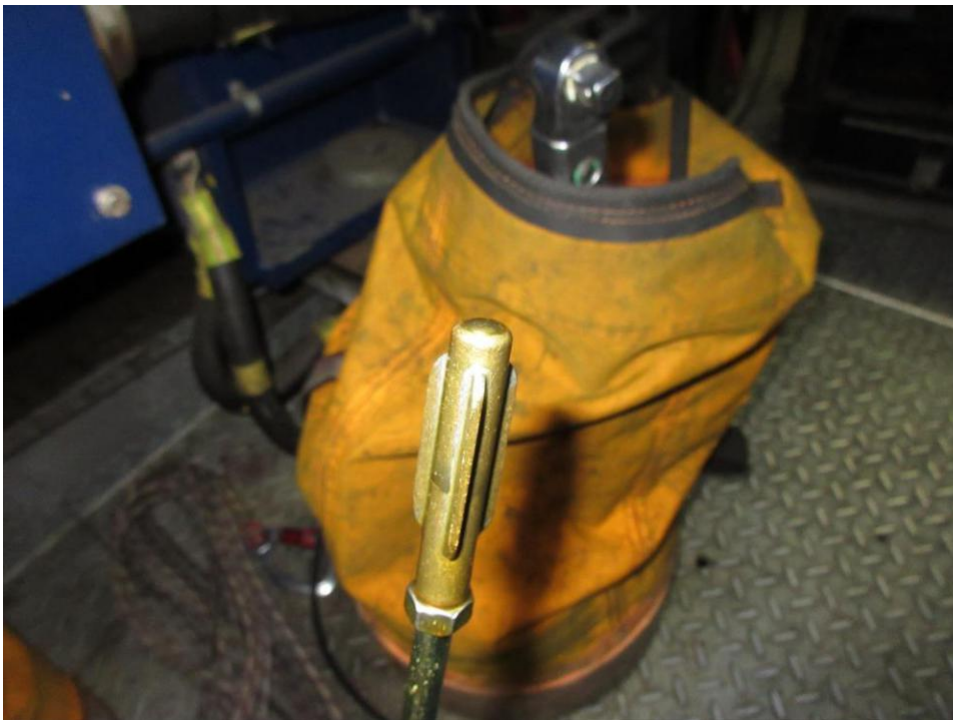
The magnet of the gearbox shows no irregularities.

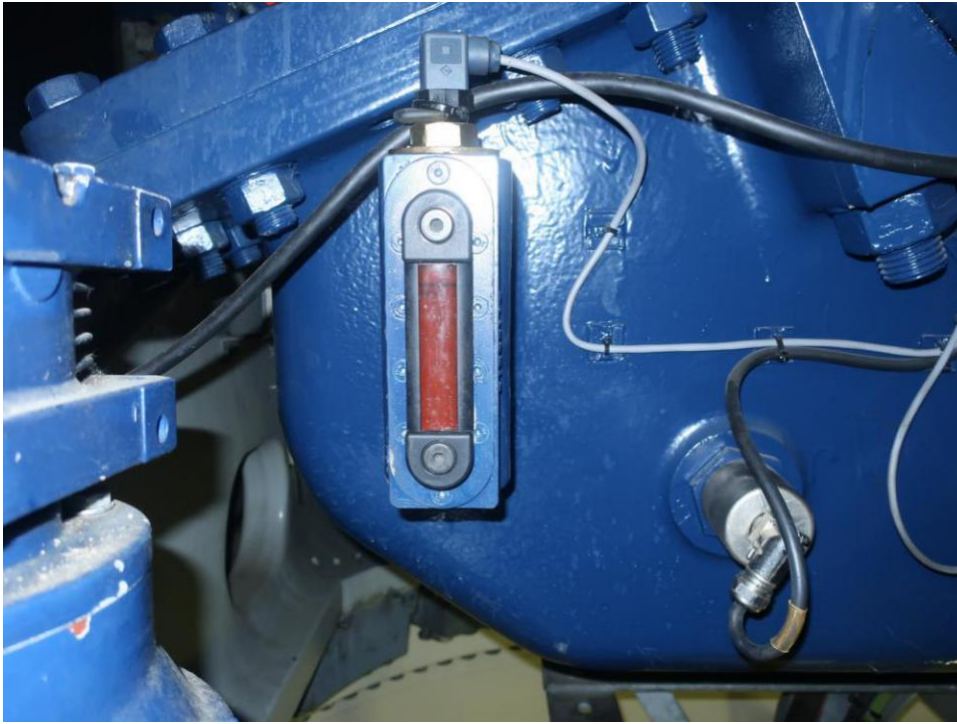
The oil level of the gearbox is ok.

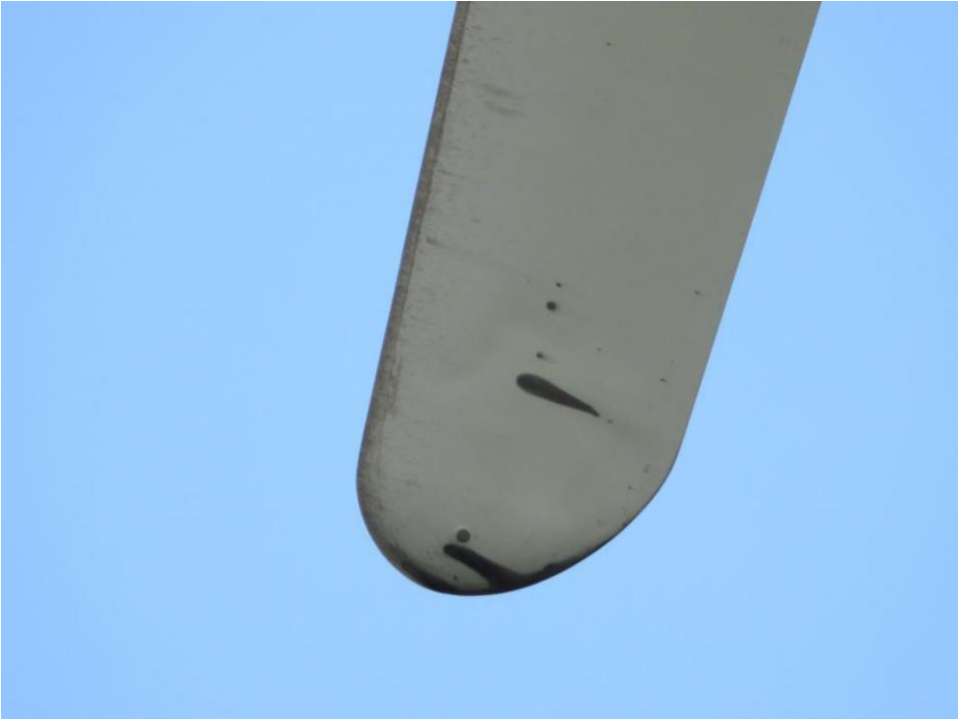
The tips show no irregularities, only a bit dirty.

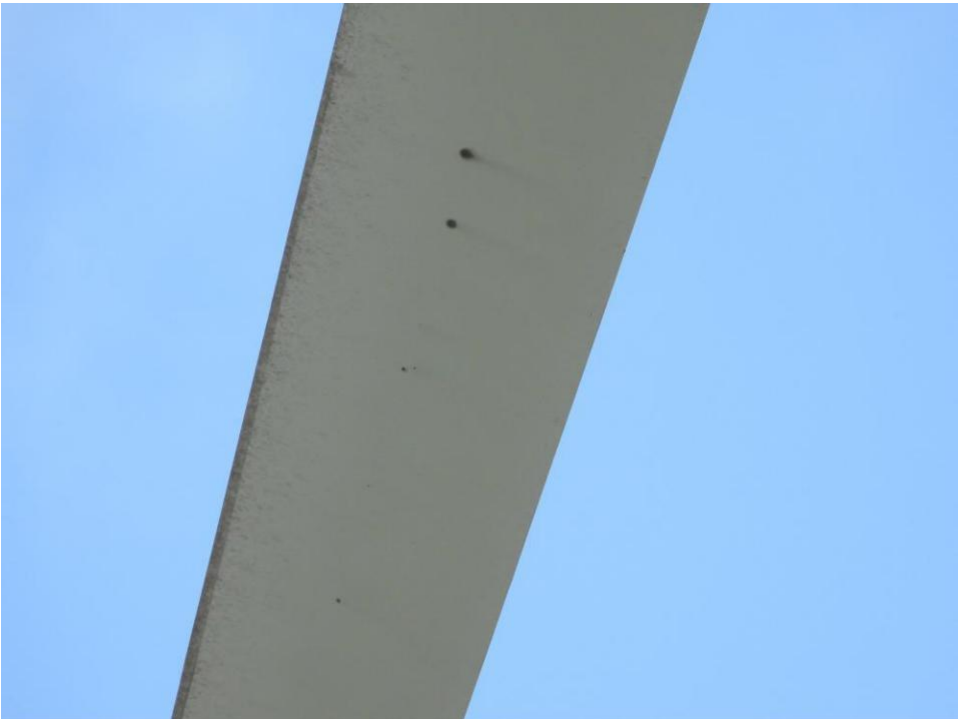
The leading edges show no irregularities.

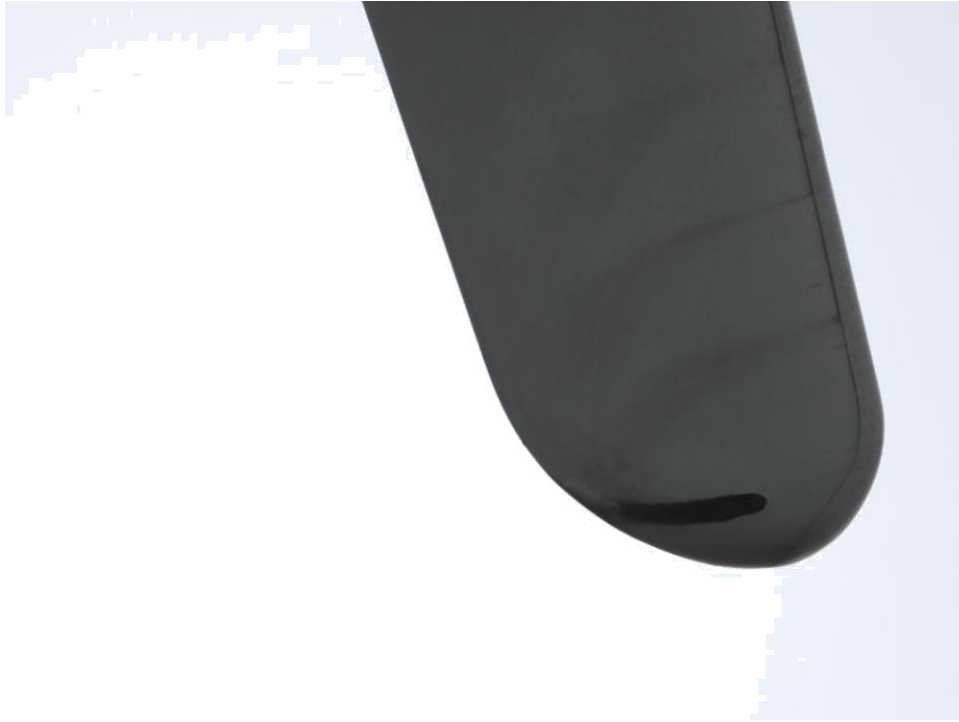
The tips show no irregularities, only a bit dirty.

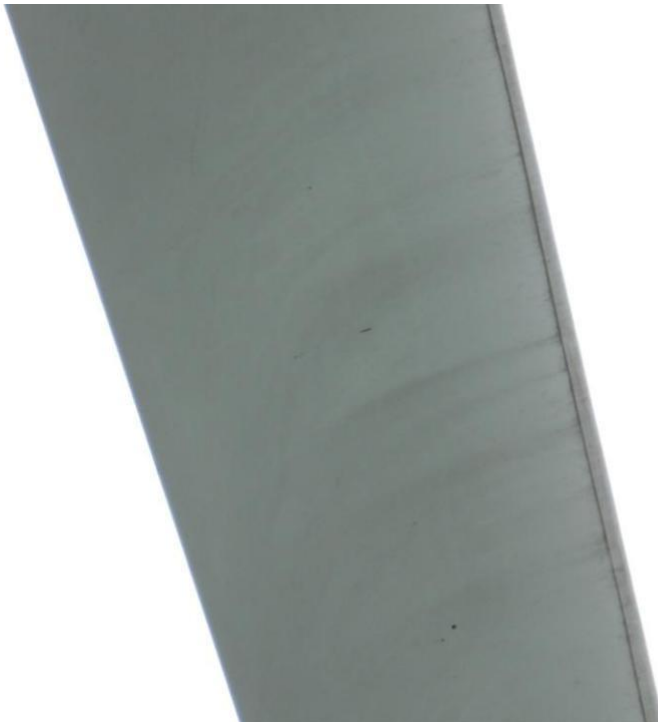
The leading edges show no irregularities.

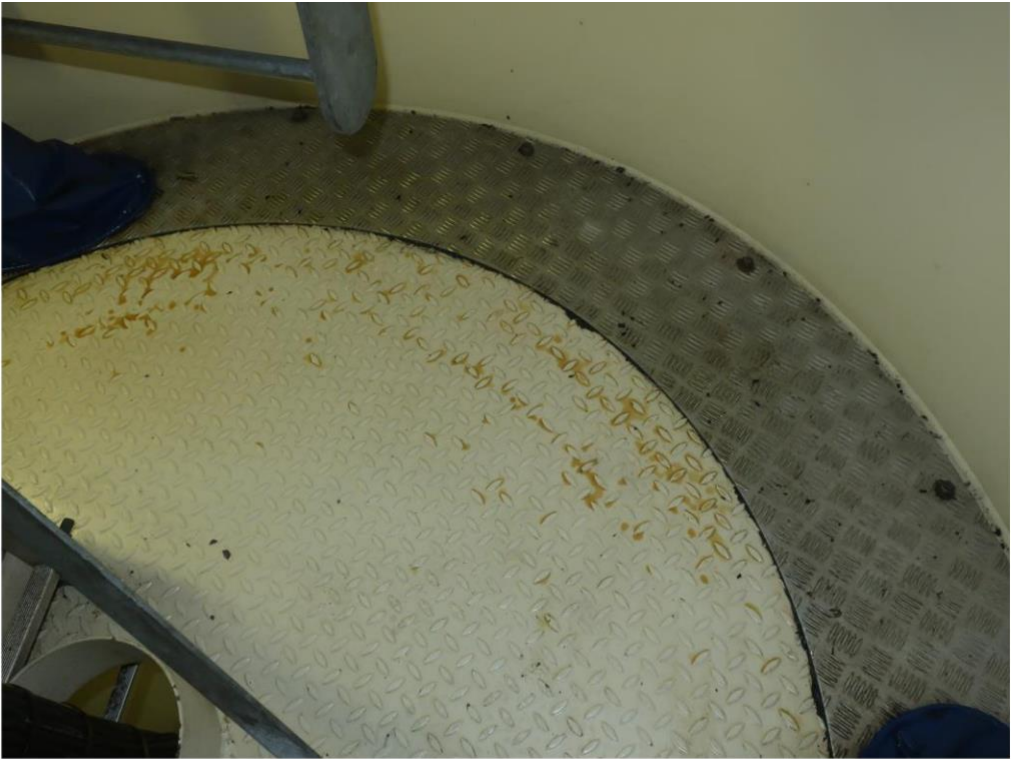
<i>Tower</i>		<i>Yaw platform: Oil pollution</i>
1.	Low

The yaw platform is polluted with oil.

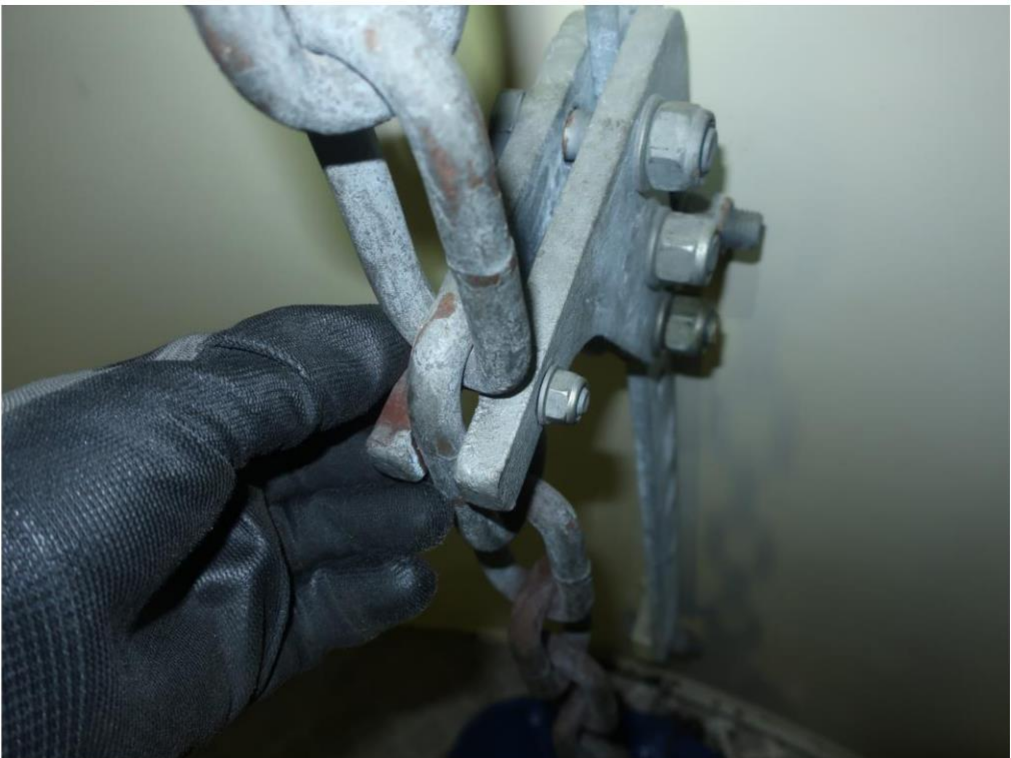
<i>Tower</i>		<i>Oscillation damper</i>
2.	Low

The M8-bolts of the oscillation damper support are loose, and the chain shows minor corrosion.

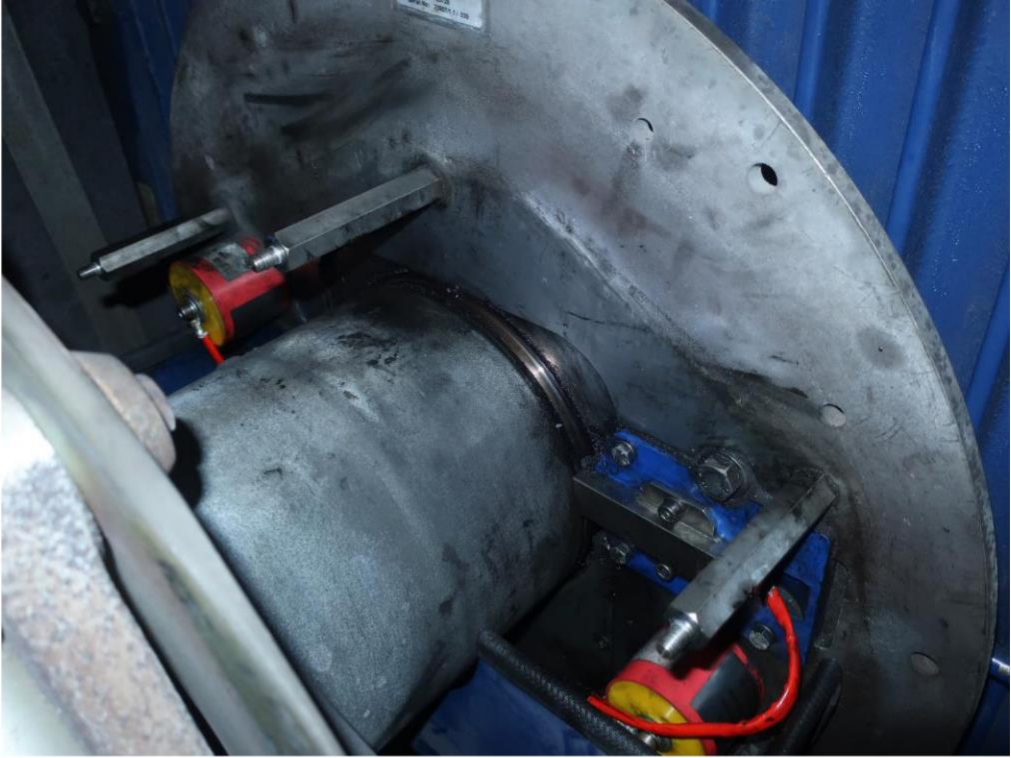
<i>Nacelle</i>		<i>Generator slipring DE</i>
3.	High

<p>The slipring at the DE shows considerable wear.</p> <p>Also, the earth brush on the right side is missing.</p>

Issue	Description
3 4 5	<p><u><i>The slipring at the Driving End of the generator shows considerable wear.</i></u></p> <p>It is recommended to replace the raceway of the slipring and also the brushes.</p>
9	<p><u><i>The spinner support shows a crack.</i></u></p> <p>It is recommended to repair the spinner support as soon as possible.</p>

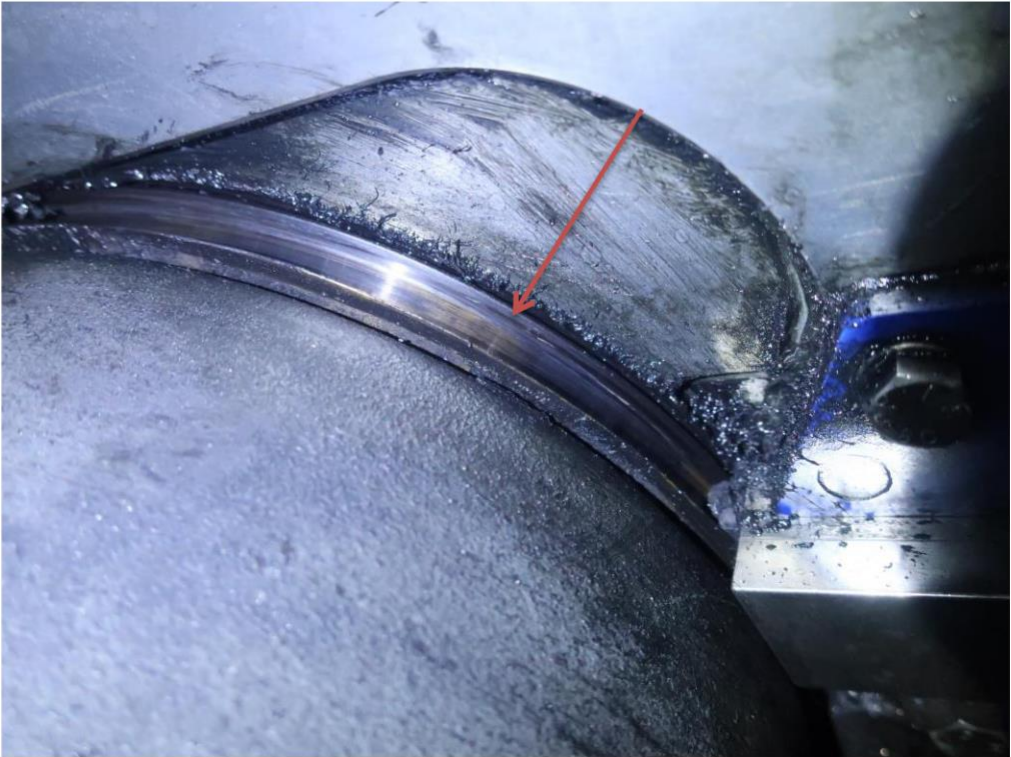
<i>Nacelle</i>		<i>Generator slipring DE</i>
4.	High

<p>The slipring at the DE shows considerable wear.</p> <p>Also, the earth brush on the right side is missing.</p>

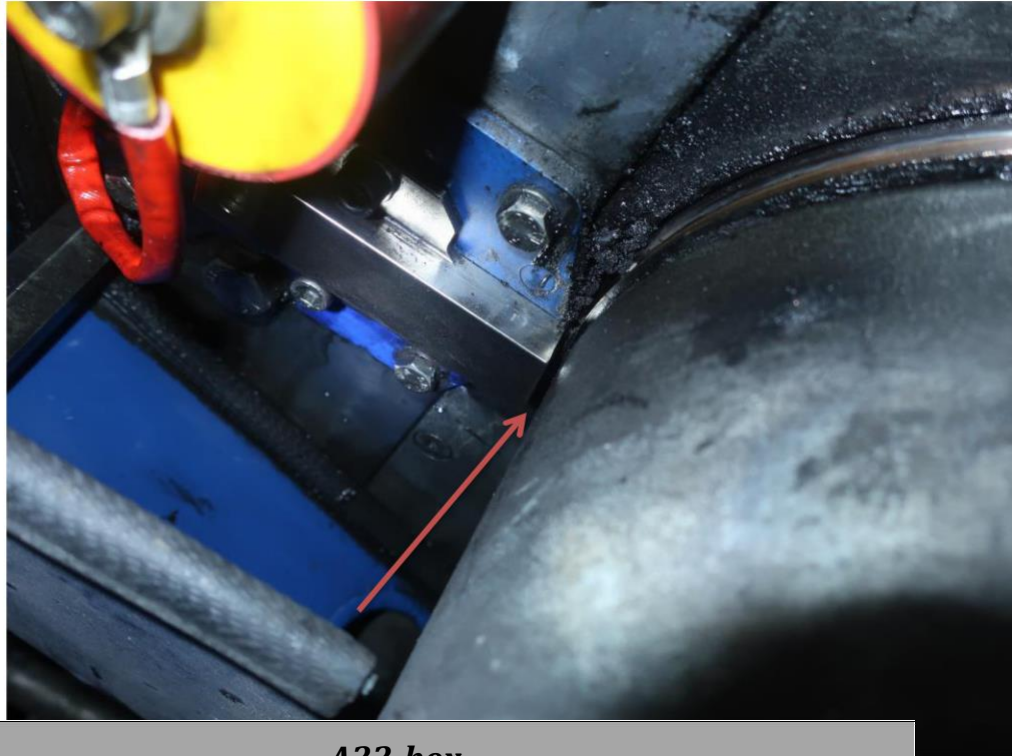
5. *High*

The slipping at the DE shows considerable wear

Also, the earth brush on the right side is missing.

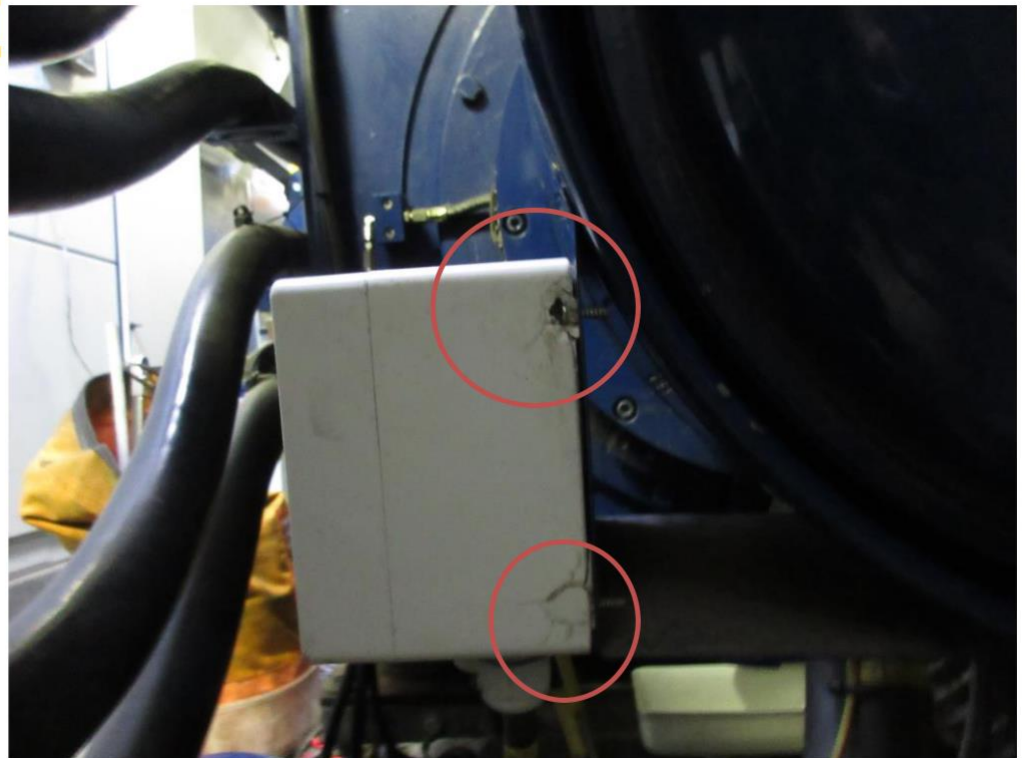
6. *Low*

The A33-box is damaged.

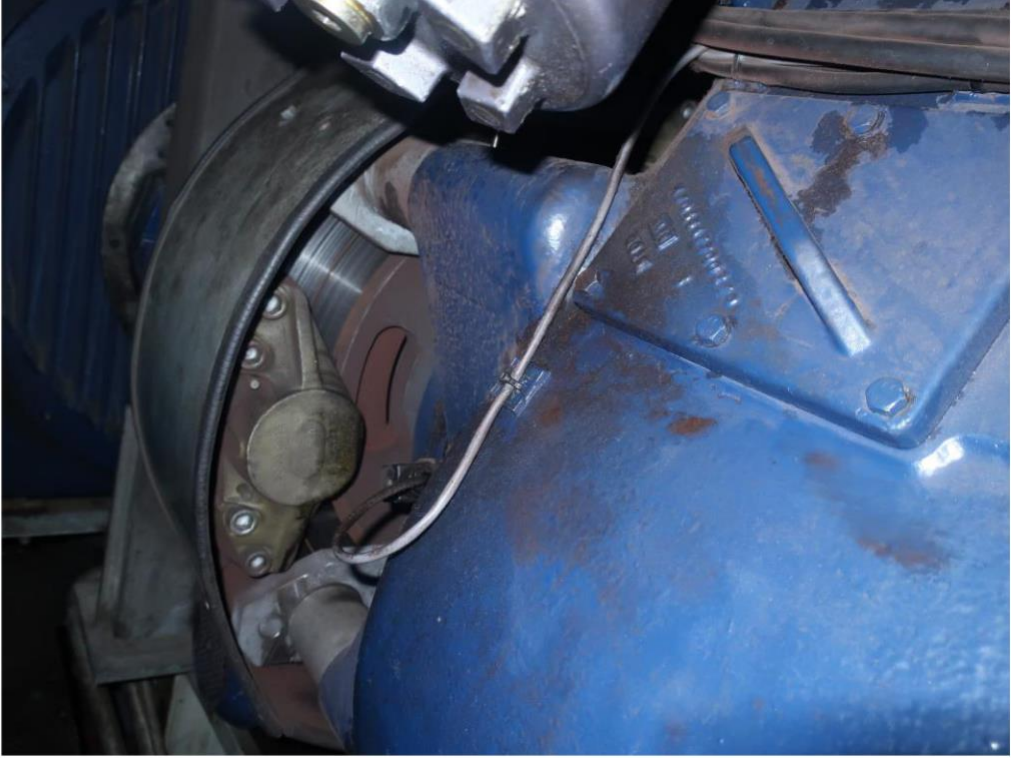
<i>Nacelle</i>		<i>Gearbox: Leakage at the rear-right</i>
7.	Low

<p>Some leakage is present near the rear right of the gearbox.</p> <p>It is recommended to clean the affected areas thoroughly to determine the source of the leakage and to solve the leakage.</p>

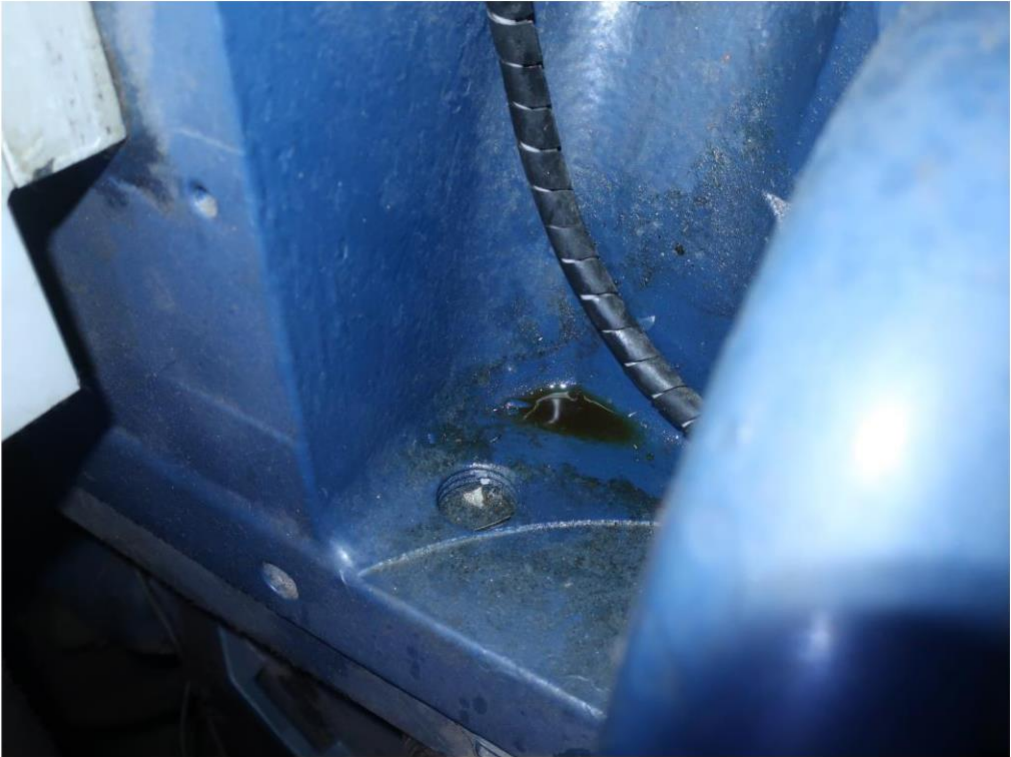
<i>Nacelle</i>		<i>Gearbox: Leakage at the rear-right</i>
8.	Low

<p>Some leakage is present near the rear right of the gearbox.</p> <p>It is recommended to clean the affected areas thoroughly to determine the source of the leakage and to solve the leakage.</p>

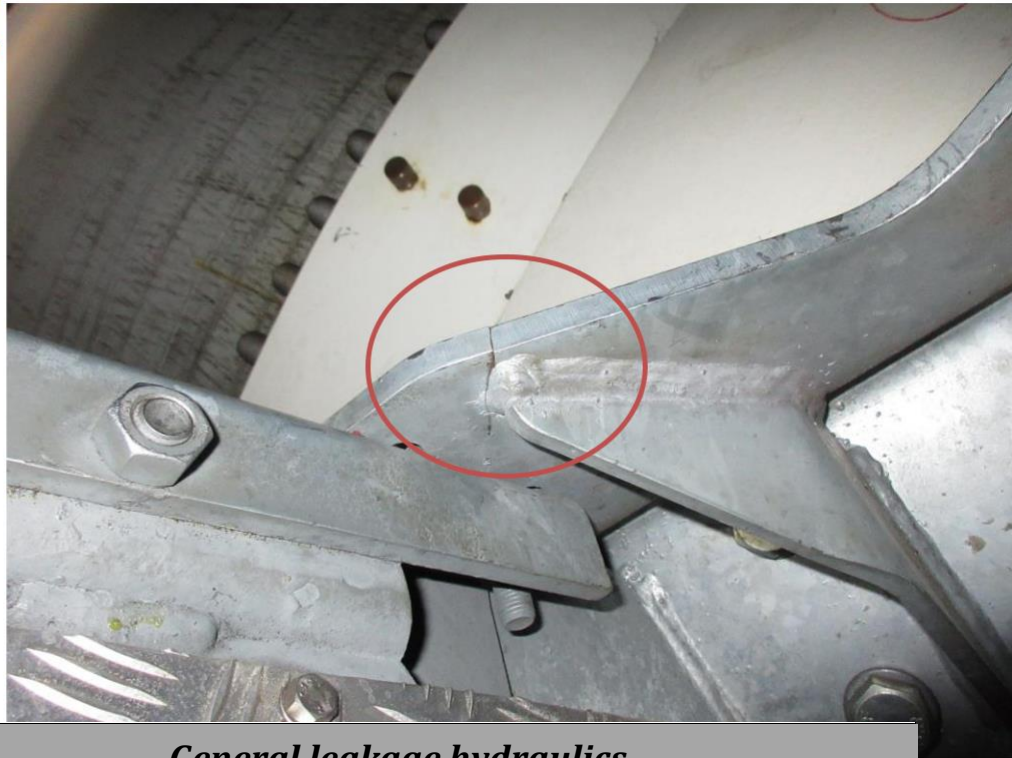
9. High

The spinner support shows a crack.

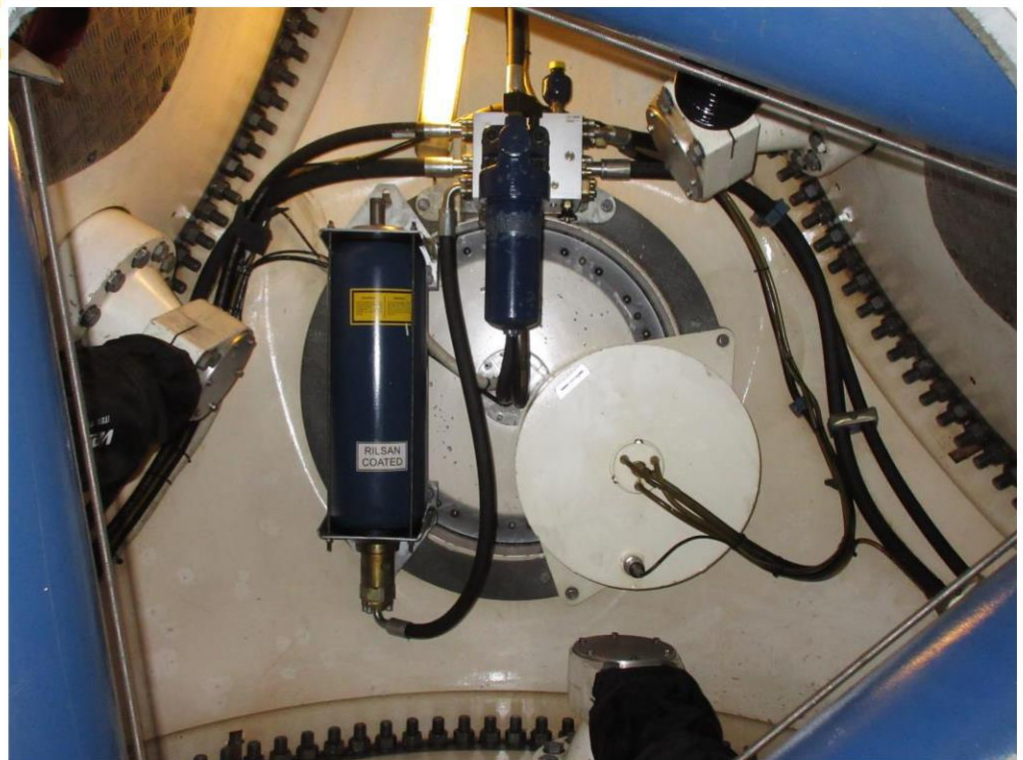
10. Low

The hub is covered in a thin layer of oil (hard to see in the photo).

It is recommended to clean the hub thoroughly to determine the source of the leakage and to solve the leakage.

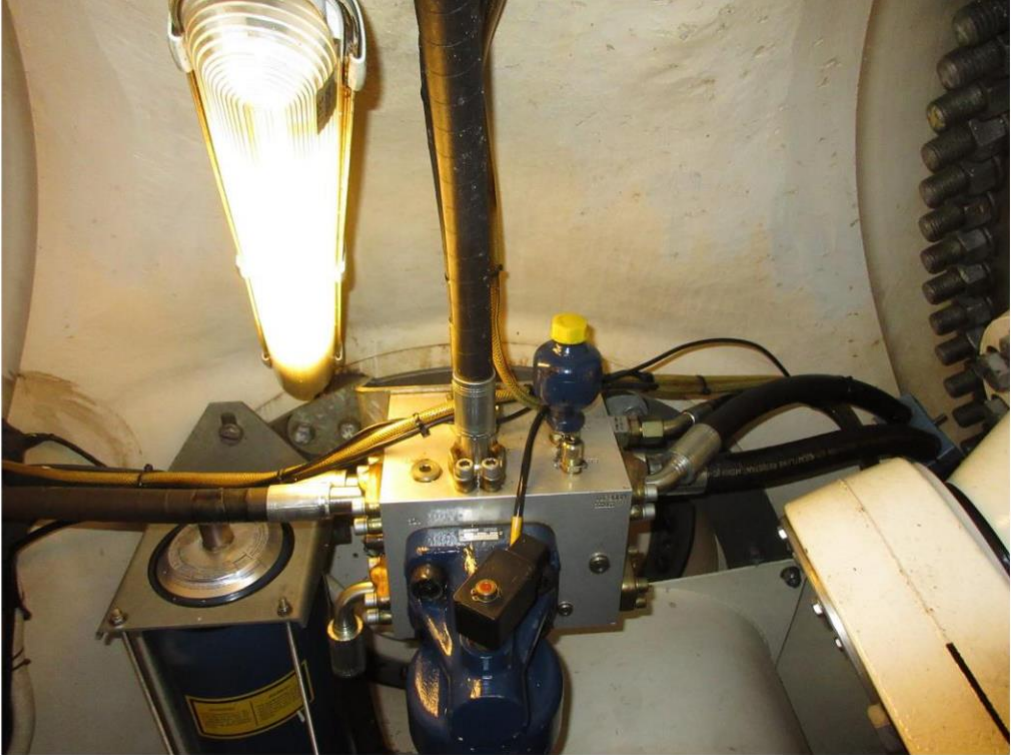
Hub		General leakage hydraulics
11.	Low

<p>The hub is covered in a thin layer of oil (hard to see in the photo).</p> <p>It is recommended to clean the hub thoroughly to determine the source of the leakage and to solve the leakage.</p>

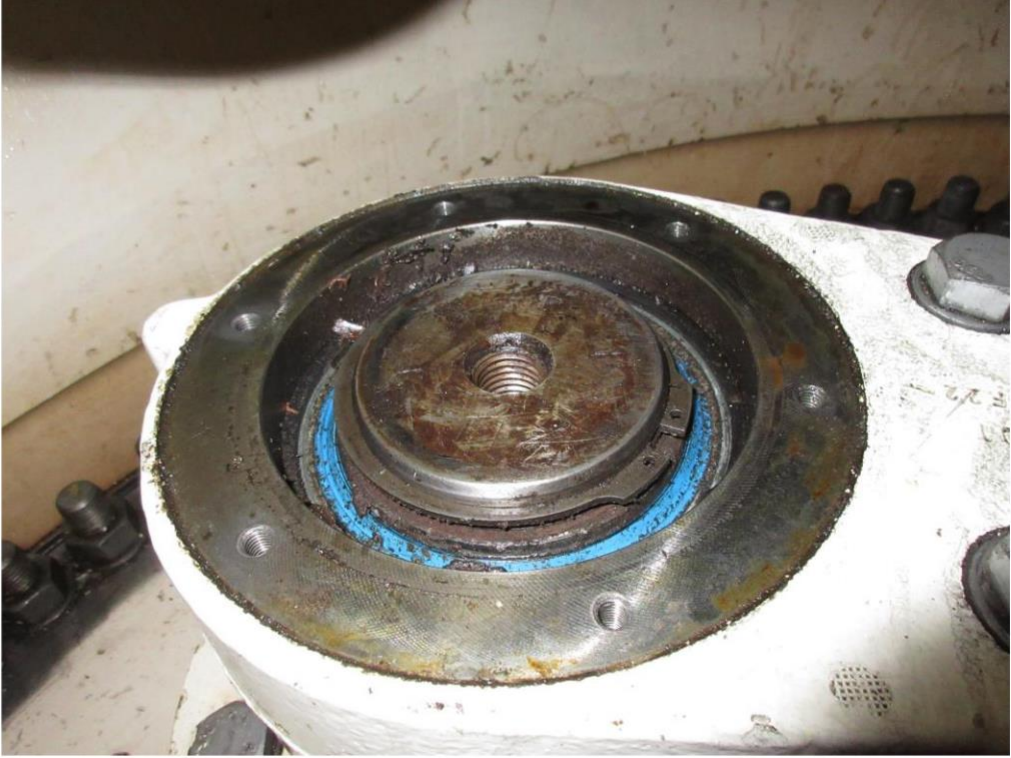
Hub		Cylinder link bearings A, B & C
13.	mon

<p>The condition of the link bearings appears to be acceptable.</p> <p>Exact measurement of the bearing play has not been performed during the inspection.</p> <p>It is recommended to check the bearing play during maintenance and replace worn parts when the clearance is not within tolerance.</p>
