SUMMARY TECHNICAL INSPECTION
WTG 20675 VESTAS V80-2000KW-690V-
50HZ-R.7035

25/11/2021

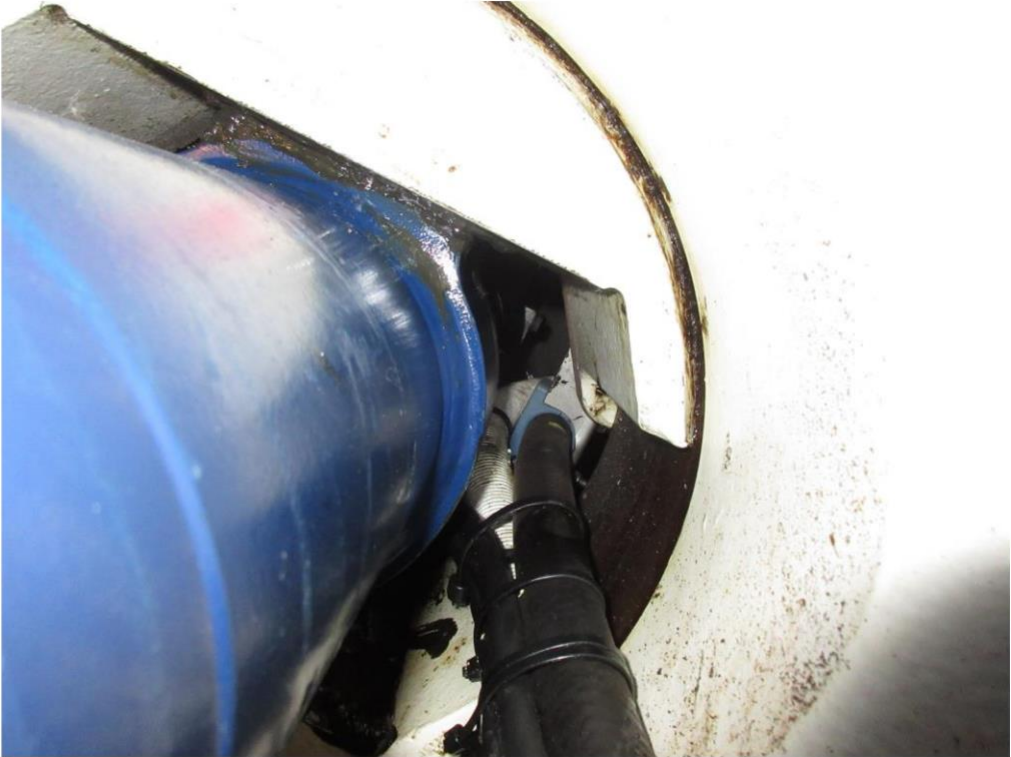
Hub		Cylinder suspension A, B & C
14.	mon

<p>The condition of the cylinder suspension bearings appears to be acceptable.</p> <p>Exact measurement of the bearing play has not been performed during the inspection.</p> <p>It is recommended to check the bearing play during maintenance and replace worn parts when the clearance is not within tolerance.</p>
